# Technical Brief

## Curved False Bottom Design Flaws

**Pressure Vessel Filter**

**Under Drain Design**

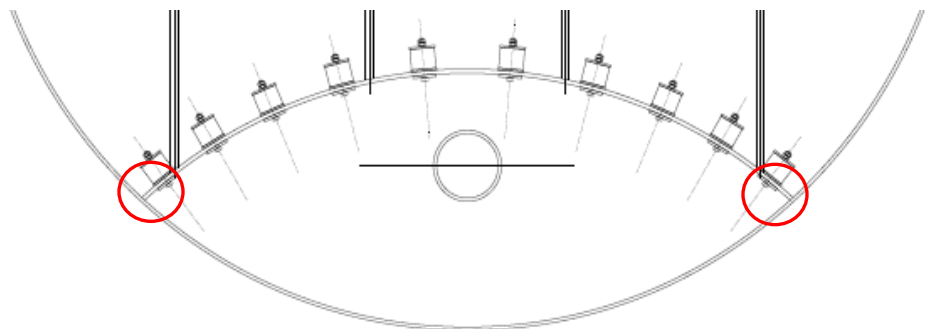
Fig. 1

The weak link in the fabrication of the arch into a pressure filter design begins with the welding. Due to the radius of the vessel wall and the curvature of the false bottom design, the ability to produce high integrity welds becomes a challenge. Welding first pass, cleaning slag and applying remaining weld passes is difficult with small confined space available to work. With the addition of an interior lining requirement, the potential for accelerated corrosion increases.

This can easily be seen in the diagram below. Fig.1

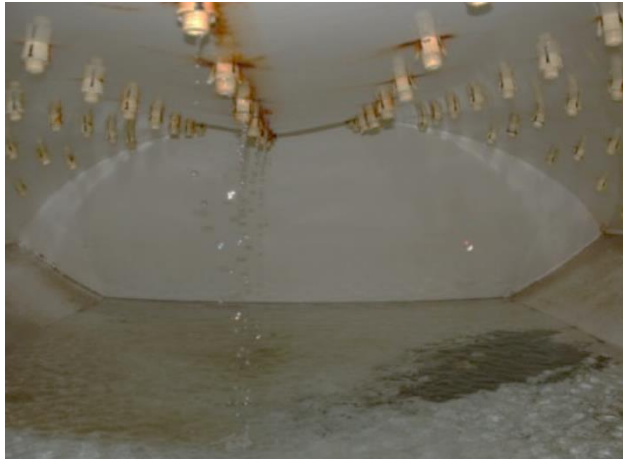
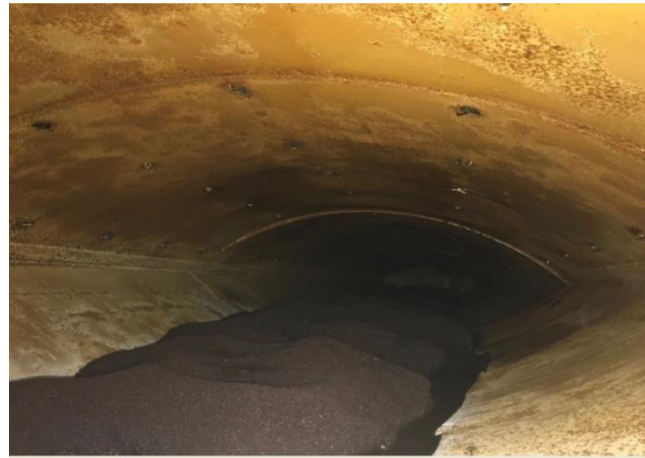
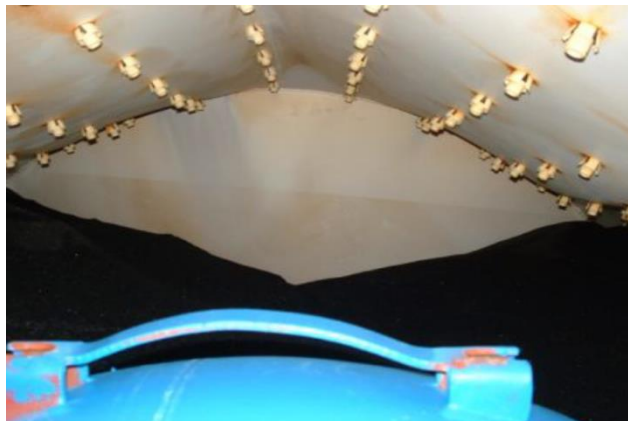
H&T has been asked to rehab or replace many of our competitors filter systems due to a variety of failure modes including false bottom failures as shown in the examples below.

All views are below the curved false bottom where only treated water should be found, not media.

The concern of high differential pressure is based on the potential for catastrophic failure of the false bottom. The cause of high DP can be:

1. Improper setting or dislocation of trough baffle plates resulting in poor cleaning during backwash.
2. Excessive contaminant loading in media bed due to infrequent backwash cycles or incomplete cleaning.
3. Defective trough based backwash collection system or air distributor piping system.
4. Clogged under drain nozzle opening slits restricting flow.

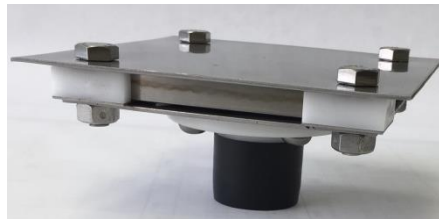
Fig.5

With over 100 years of experience, H&T has standardized on what we feel that design should look like. The H&T Self-Cleaning Sand Valve under drain with header-lateral piping system and concrete sub-fill provides a design to last many decades.

H&T Self-Cleaning Sand Valve.

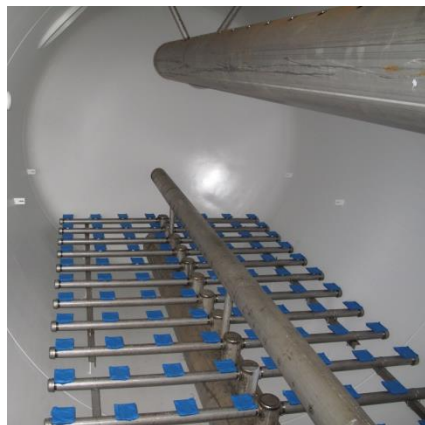
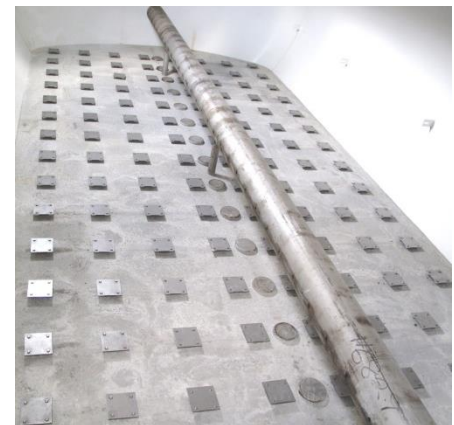
**Sand Valve Under Drain System - Pre & Post Concrete Fill**
