CLIENT: Hungerford & Terry, Inc.

Hungerford & Terry Ships Delivers Two of the Five GAC Filters for the Buchman Direct Diversion Project for Santa Fe, New Mexico

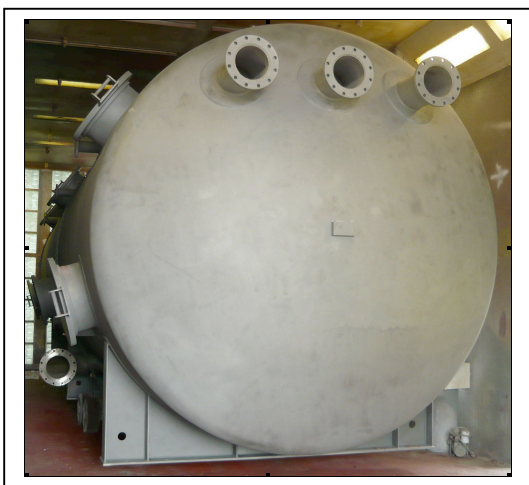
Photo A shows the completed tank by Hungerford & Terry, Inc. standing upright, looking at the three inlet connections on the end head and prime painted. In photo B, the second tank is shown on its side, in fabrication before hydro test and painting.

Clayton, NJ - Here are two of the five 12-foot diameter by 40-feet long horizontal, multi-cell GAC (granulated activated carbon) filters with a 3,000 cubic foot bed of GAC per filter. These filters, engineered by Hungerford & Terry, Inc. are for pretreatment to the membrane system that treats 15 million gallons of water per day for the residents and businesses in Santa Fe, New Mexico, City and County. This contract to Hungerford & Terry is reported to be \$2.3 million dollars. The entire Buchman Direct Diversion project is expected to be completed in 2011.
