Hungerford & Terry Delivers Two of the Five GAC Filters for the Buchman Direct Diversion Project for Santa Fe, New Mexico

Clayton, NJ - Shown are two of the five 12-foot diameter by 40-feet long horizontal, multi-cell GAC (granulated activated carbon) filters with a 3,000 cubic foot bed of GAC per filter. These filters, engineered by Hungerford & Terry, Inc. are for pretreatment to the membrane system that treats 15 million gallons of water per day for the residents and businesses in Santa Fe, New Mexico, City and County. This contract to Hungerford & Terry is reported to be \$2.3 million dollars.

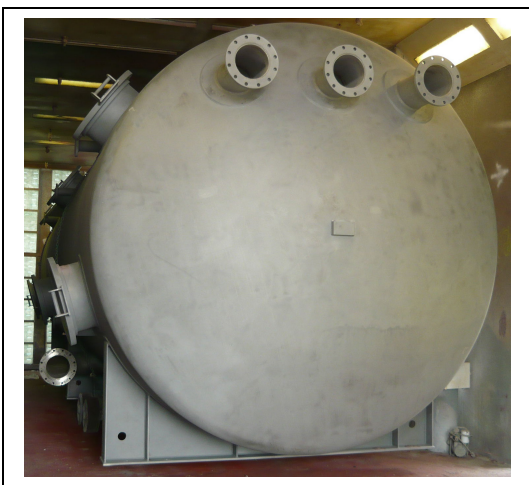
Photo A shows the completed tank by Hungerford & Terry, Inc. standing upright, looking at the three inlet connections on the end head and prime painted. In photo B, the second tank is shown on its side, in fabrication before hydro test and painting.
